SINTEF Building and Infrastructure

Assignment Report

Hunton Fiber - Racking strength and stiffness of soft fibreboards impregnated with bitumen

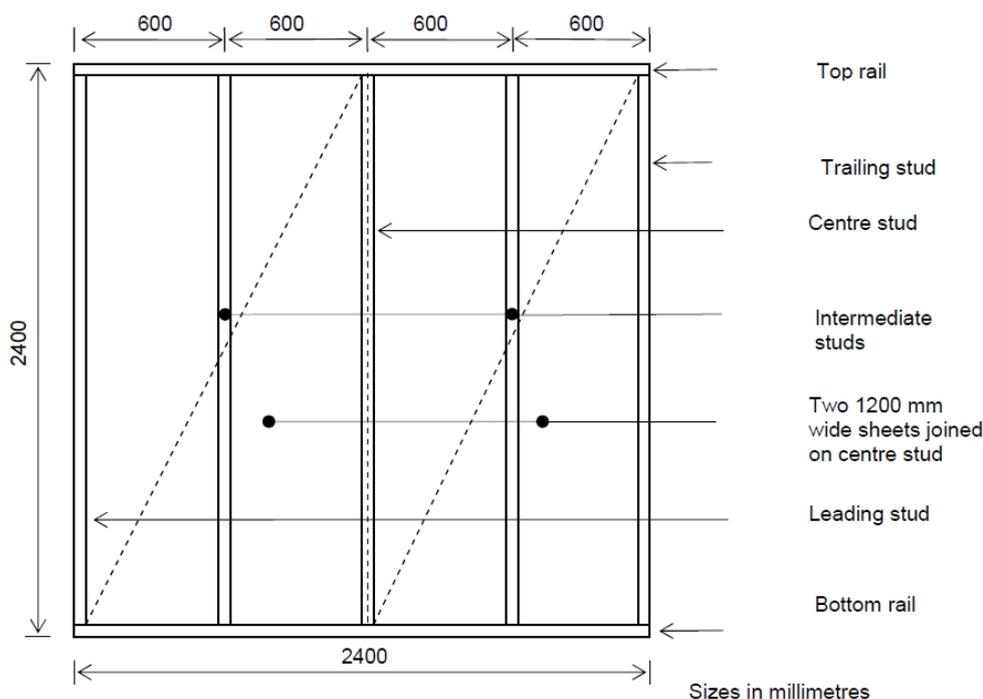
The fibreboards were mounted on a stud wall with a size of 2.4 m x 2.4 m (height x width), see Figure 1. It was used timber 48 mm x 98 mm, quality C24 sorted by EN 519. Studs were placed c / c 600 mm, and were fixed with 2 pcs. 3.4 mm x 95 mm nails through the top and bottom rail. Wood and nails have been acquired by a local building materials dealer.

Figure 1 The trial panel of 48 mm x 98 mm, quality C24

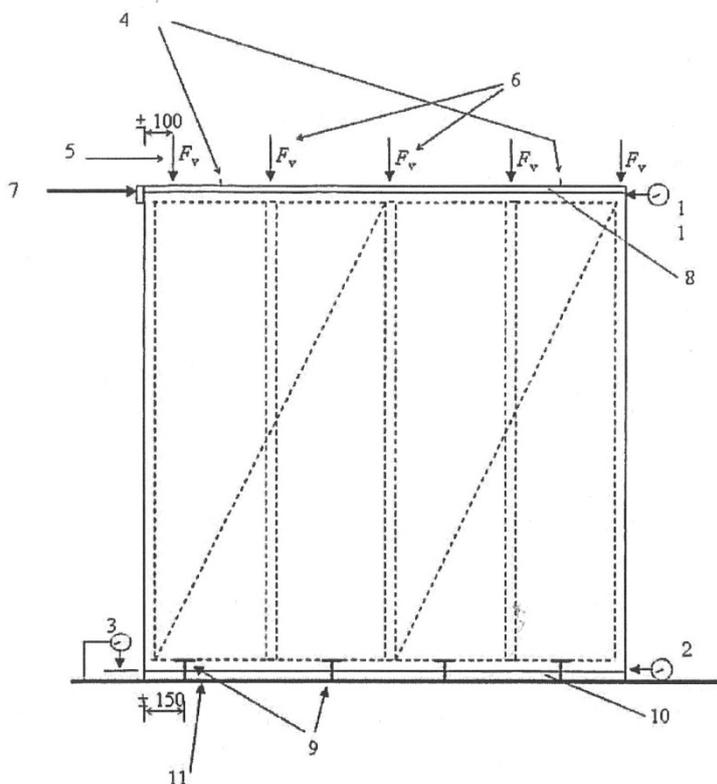
Vertical load $F_v = 1$ kN was applied over each stud, see Figure 2 This load was maintained throughout the test.

Figure 2 Location of vertical load F_v

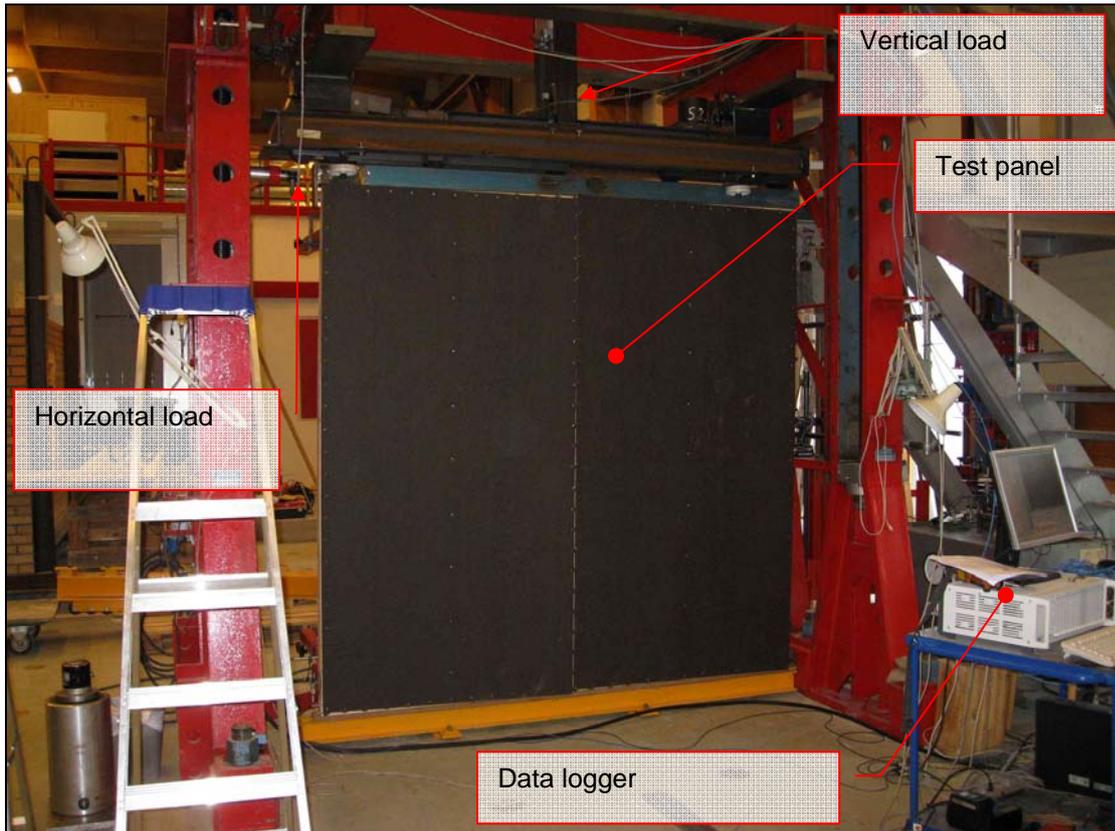
Photo 1: Hunton fiber AS. Test panel installed in test rig, front side.

The bottom rail in the test frame was clamped against the test rig. Displacement sensors which measured horizontal and vertical displacements were mounted on both the top and bottom rails.

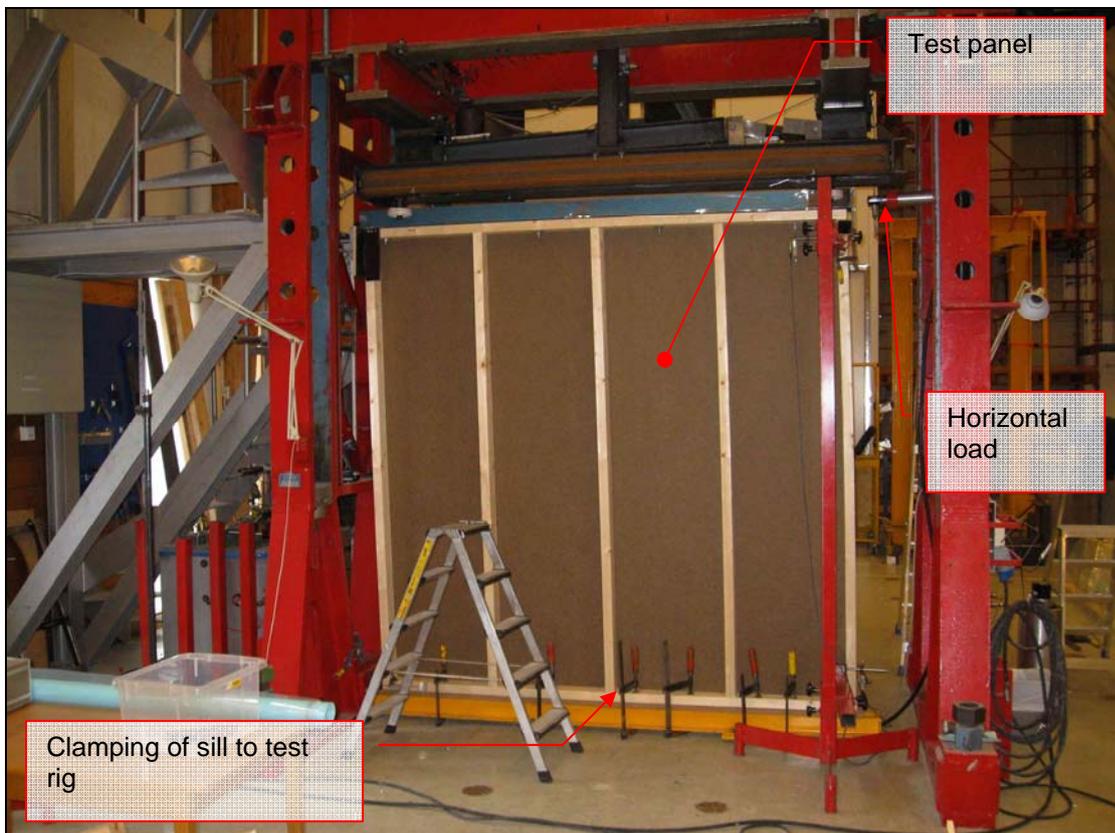
Photo 2: Hunton fiber AS. Test panel installed in test rig, back side.

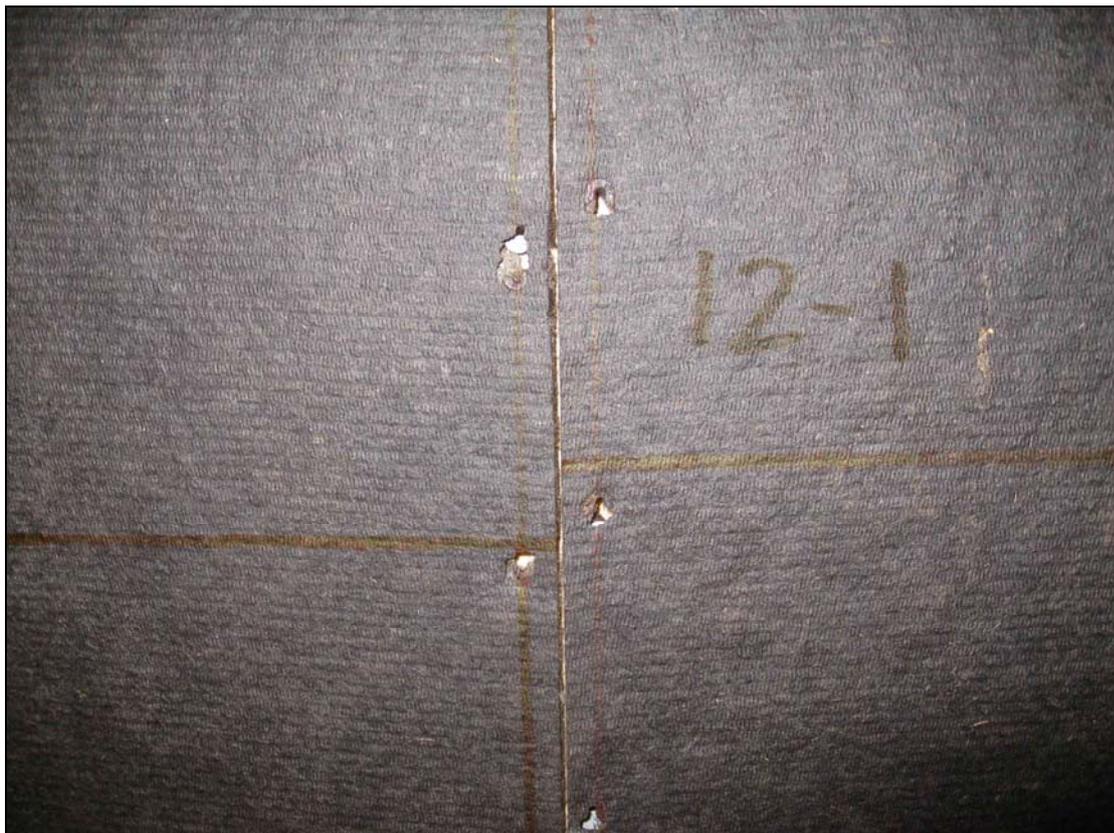
Photo 3: Hunton fiber AS. Typical displacement at the vertical joint between two fibreboards, intermediate stud.

At failure nails in the bottom sill were torn out of the fibreboard in the corner of the test panel. Sill and stud was pulled apart during the test. We also noted the displacement between the plates in the vertical joint, see photo 3.

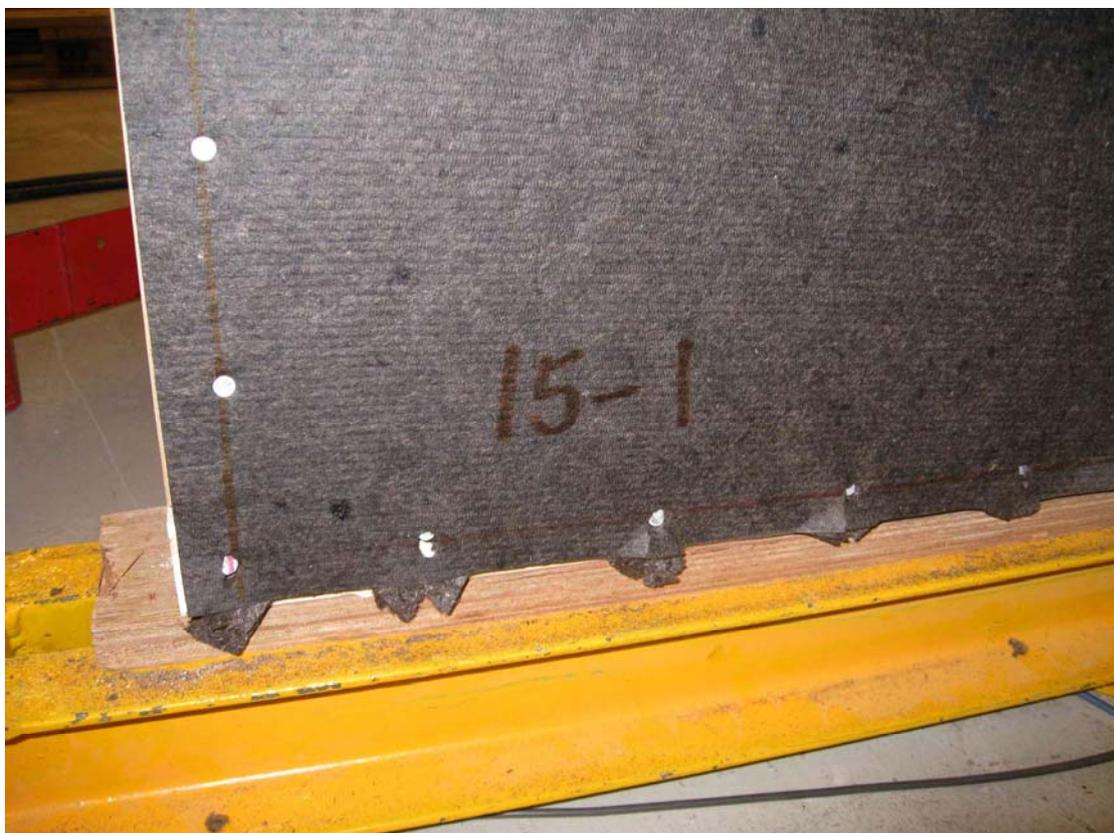
Photo 4: Hunton fiber AS. Typical tear out of nails in the corner of the bottom sill, caused by tension in the stud.

At failure nails in the bottom sill were torn out of the fibreboard in the corner of the test panel. Sill and stud was pulled apart during the test. Nails were bent along the edges. We also noted the displacement between the plates in the vertical joint.

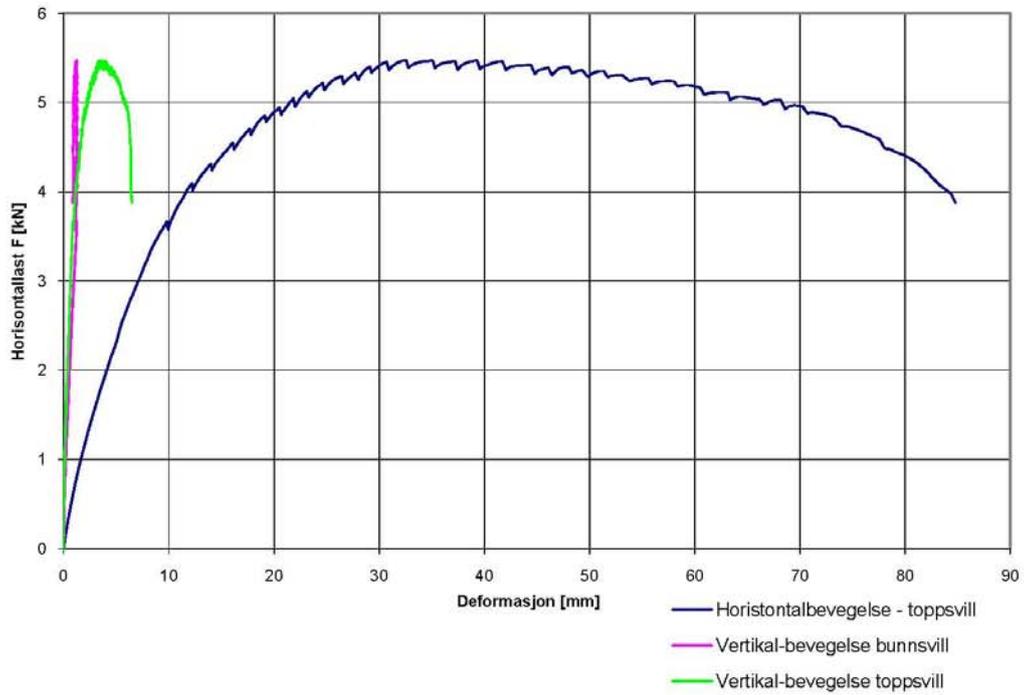
Maks last (kN) 5,47

Horisontallast (kN)	0,55	1,09	1,64	2,19	2,74	3,28	3,83	4,38	4,92	5,47
Hor.defomasjon (mm)	0,80	1,88	3,18	4,65	6,17	8,11	10,85	14,87	20,41	32,16
Vert. løft bunnsvill (mm)	0,02	0,13	0,27	0,41	0,58	0,76	1,03	1,49	2,01	3,38

Result 12-1: Hunton fiber AS. 12 mm, 1. test

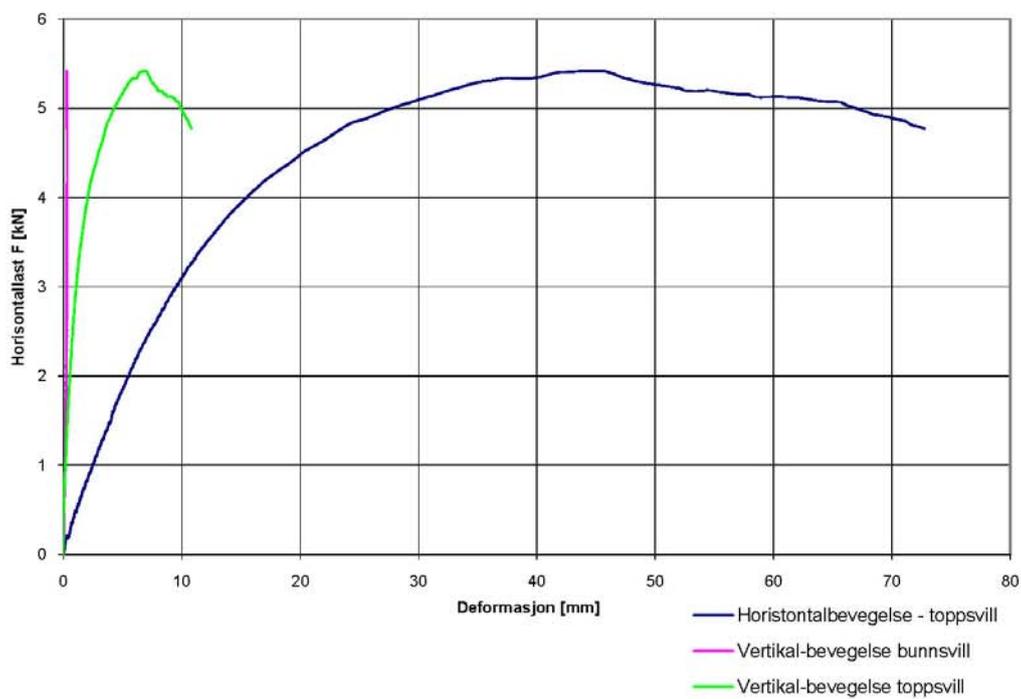
Maks last (kN) 5,42

Horisontallast (kN)	0,54	1,08	1,63	2,17	2,71	3,25	3,79	4,33	4,88	5,42
Hor.defomasjon (mm)	1,18	2,68	4,29	6,05	8,25	10,73	13,97	18,57	25,46	43,44
Vert. løft bunnsvill (mm)	0,02	0,18	0,37	0,60	0,88	1,24	1,79	2,61	3,87	6,69

Result 12-2: Hunton fiber AS. 12 mm, 2. test

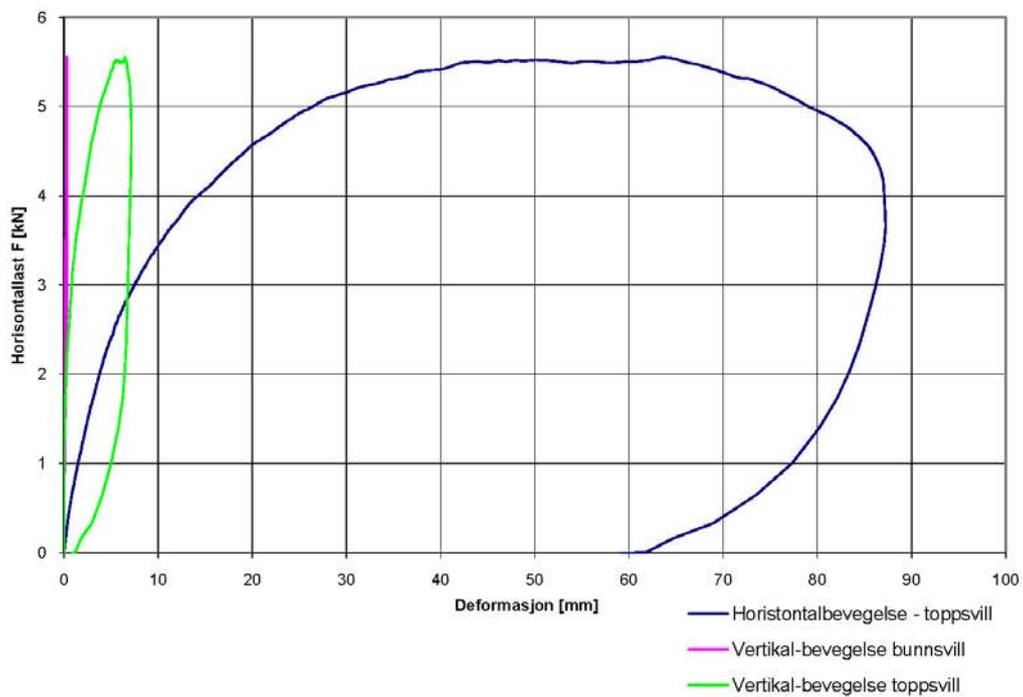
Maks last (kN) 5,55

Horisontallast (kN)	0,56	1,11	1,67	2,22	2,78	3,33	3,89	4,44	5,00	5,55
Hor.defomasjon (mm)	0,72	1,74	2,97	4,40	6,41	9,35	13,22	18,72	26,45	63,55
Vert. løft bunnsvill (mm)	0,00	0,01	0,14	0,34	0,69	1,12	1,82	2,69	3,83	6,47

Result 12-3: Hunton fiber AS. 12 mm, 3. test

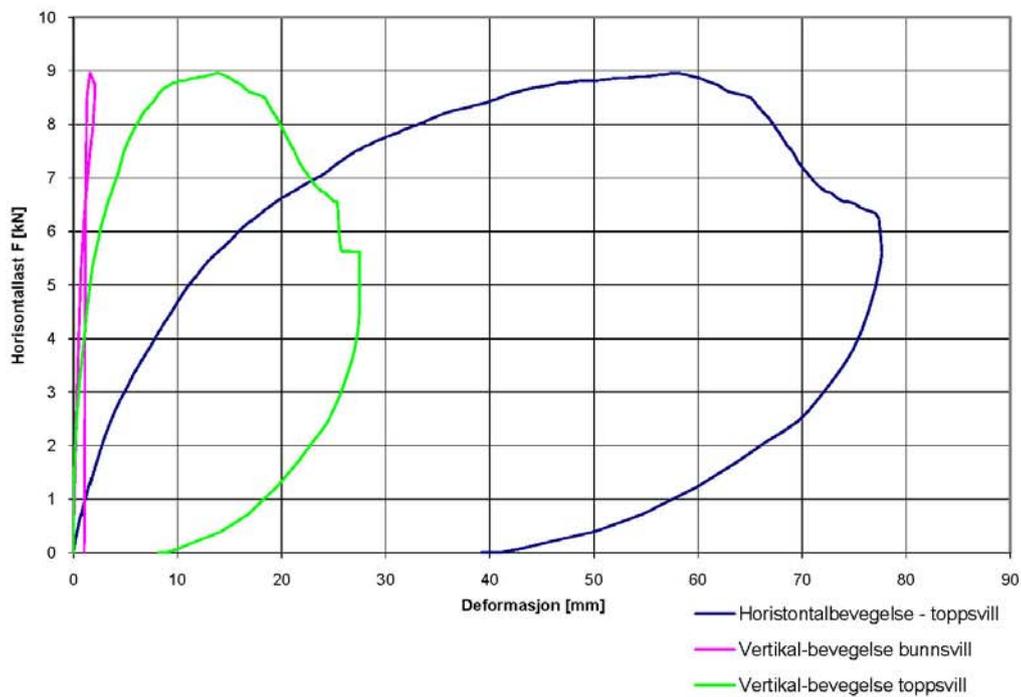
Maks last (kN) 8,96

Horisontallast (kN)	0,90	1,79	2,69	3,58	4,48	5,37	6,27	7,16	8,06	8,96
Hor.defomasjon (mm)	1,02	2,42	4,09	6,57	9,44	12,65	17,69	24,75	34,11	57,61
Vert. løft bunnsvill (mm)	0,00	0,13	0,38	0,80	1,29	1,87	2,95	4,42	6,32	13,72

Result 15-1: Hunton fiber AS. 15 mm, 1. test

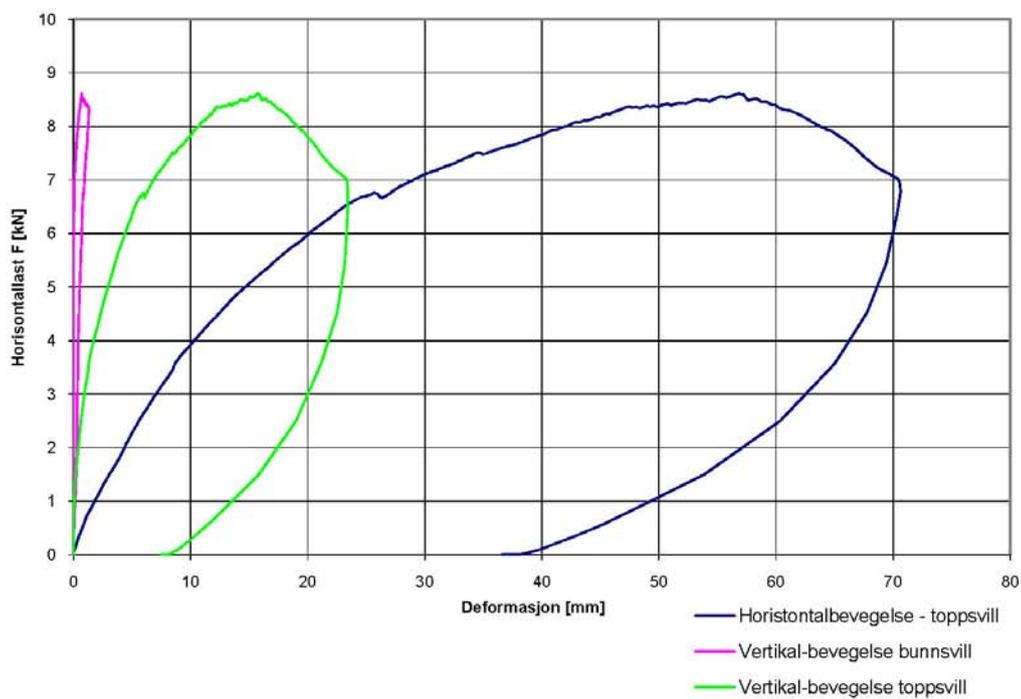
Maks last (kN) 8,61

Horisontallast (kN)	0,86	1,72	2,58	3,45	4,31	5,17	6,03	6,89	7,75	8,61
Hor.defomasjon (mm)	1,51	3,75	5,87	8,47	11,56	15,66	20,40	28,00	38,85	56,83
Vert. løft bunnsvill (mm)	0,05	0,30	0,70	1,26	2,11	3,22	4,48	6,54	9,69	15,76

Result 15-2: Hunton fiber AS. 15 mm, 2. test

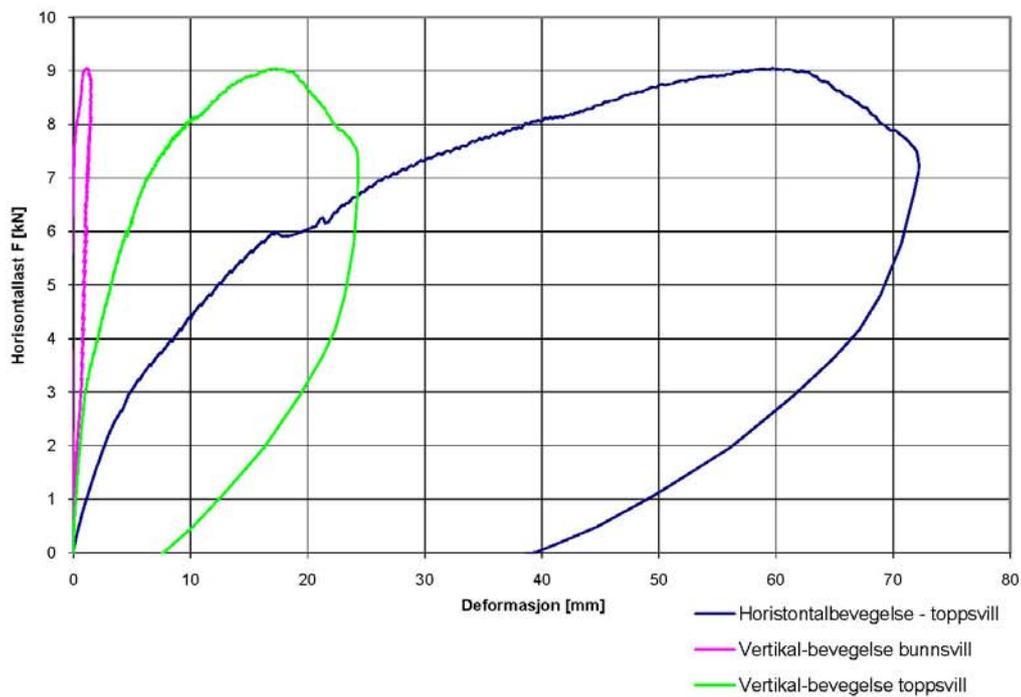
Maks last (kN) 9,05

Horisontallast (kN)	0,90	1,81	2,71	3,62	4,52	5,43	6,33	7,24	8,14	9,05
Hor.defomasjon (mm)	0,99	2,35	4,29	7,02	10,42	14,23	22,30	28,84	41,56	58,71
Vert. løft bunnsvill (mm)	0,18	0,49	0,89	1,63	2,65	3,69	5,15	6,94	10,59	16,82

Result 15-3: Hunton fiber AS. 15 mm, 3. test

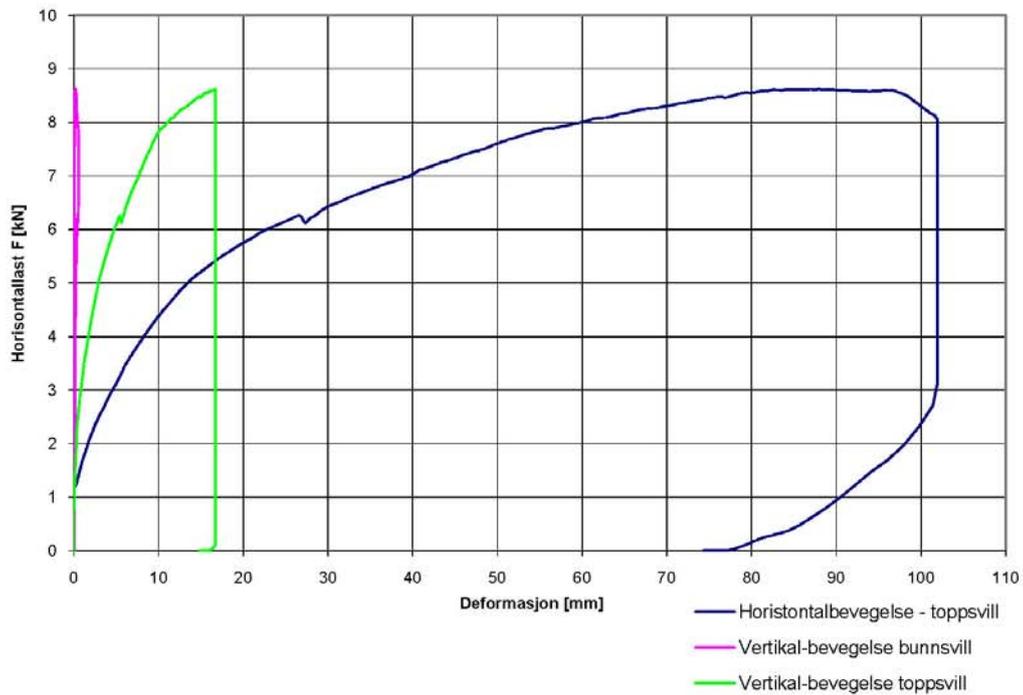
Maks last (kN) 8,62

Horisontallast (kN)	0,86	1,72	2,59	3,45	4,31	5,17	6,04	6,90	7,76	8,62
Hor.defomasjon (mm)	0,00	1,13	3,25	6,04	9,67	14,79	23,29	37,87	53,14	84,13
Vert. løft bunnsvill (mm)	0,05	0,24	0,55	1,18	2,07	3,21	4,86	7,39	9,82	16,75

Result 25-1: Hunton fiber AS. 25 mm, 1. test

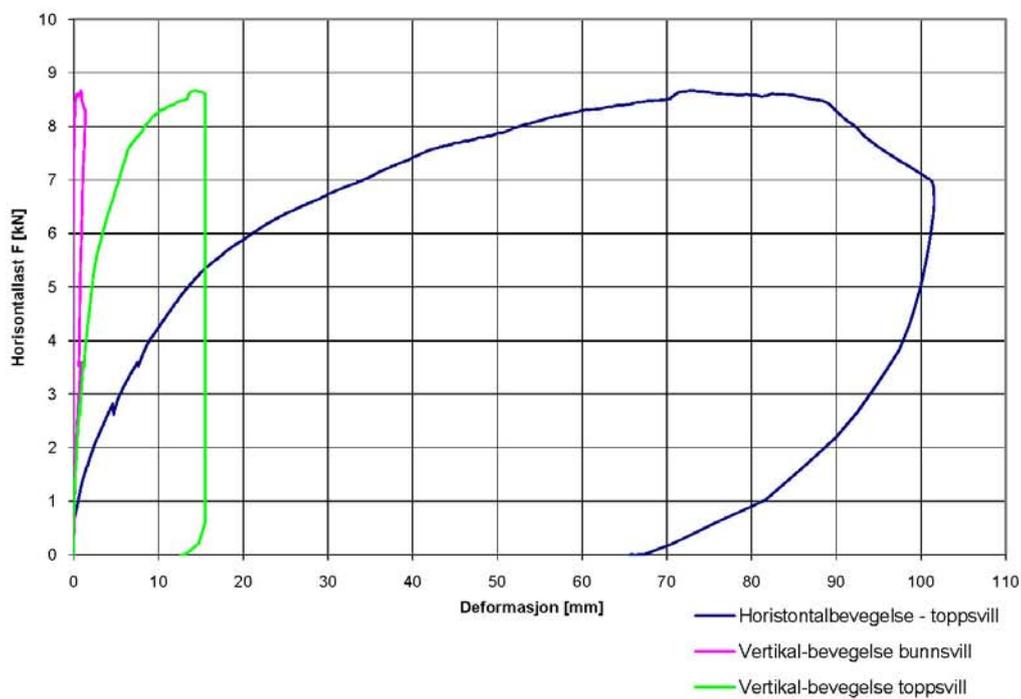
Maks last (kN) 8,67

Horisontallast (kN)	0,87	1,73	2,60	3,47	4,34	5,20	6,07	6,94	7,80	8,67
Hor.defomasjon (mm)	0,38	1,78	3,96	7,10	10,41	14,64	21,88	33,36	48,66	73,01
Vert. løft bunnsvill (mm)	0,05	0,28	0,62	1,09	1,69	2,31	3,54	5,25	7,56	14,34

Result 25-2: Hunton fiber AS. 25 mm, 2. test

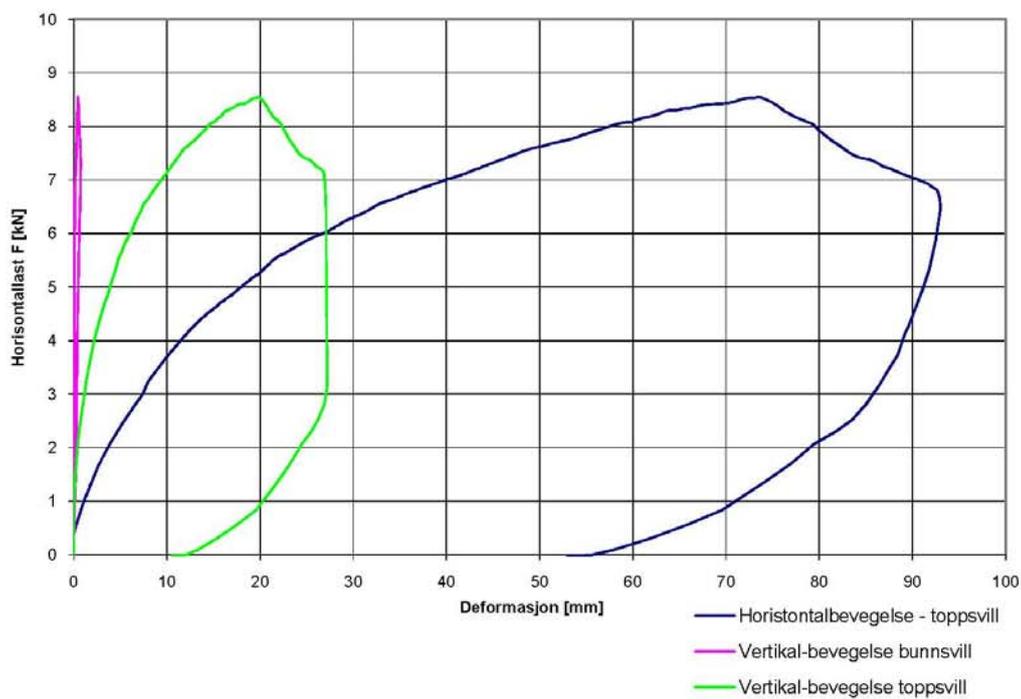
Maks last (kN) 8,55

Horisontallast (kN)	0,86	1,71	2,57	3,42	4,28	5,13	5,99	6,84	7,70	8,55
Hor.defomasjon (mm)	0,84	2,83	5,72	8,80	12,98	18,98	26,64	37,43	51,78	73,60
Vert. løft bunnsvill (mm)	0,00	0,28	0,79	1,53	2,62	4,15	6,07	8,75	12,64	19,84
